Case Study: Centrifugal Application of Mainstay ML-72 Mortar on Horizontal Drainage Pipe

Contractor: H&R Underground

Location: Berkeley, CA

Structure: 50 feet of 24 inch diameter corrugated metal pipe

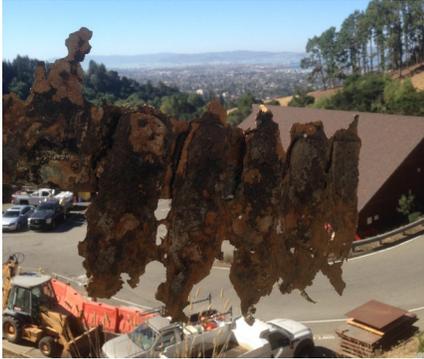
Corrosion in corrugated metal drainage pipes can often lead to structural deterioration and eventual collapse. Many owners are solving this problem by cement mortar lining drainage pipes before corrosion becomes detrimental. H&R Plumbing recently performed an application of Mainstay ML-72 Restoration Mortar on 50' of corrugated metal culvert using Madewell's horizontal mortar spinner.

To begin, H&R used a vacuum truck to remove all loose dirt, debris, and corroded material that had settled in the bottom of the culvert. The pipe was so badly deteriorated in some areas that entire sections had rusted through, leaving only the surrounding soil. The work was performed over a weekend to prevent any issues associated with heavy traffic.

After cleaning, H&R Plumbing utilized Madewell's horizontal mortar spinner to centrifugally apply 3/4" of Mainstay ML-72 Restoration Mortar to the inside

diameter of the culvert. This mortar spinner is capable of pulling heavy loads horizontally at a very controlled and slow rate of speed. It pulls a load rated chain using a uniquely constructed air motor, gear, and sprocket set up. The use of a chain for this application means that the pulling device is able to retract long lengths of mortar hose along with the centrifugal mortar applicator.
