Case Study: Installation of Mainstay Composite Liner in Oakley, CA Steel Lift Station

Contractor: H&R Plumbing
Location: Oakley, CA
Structure: lift station
Date: December 2017

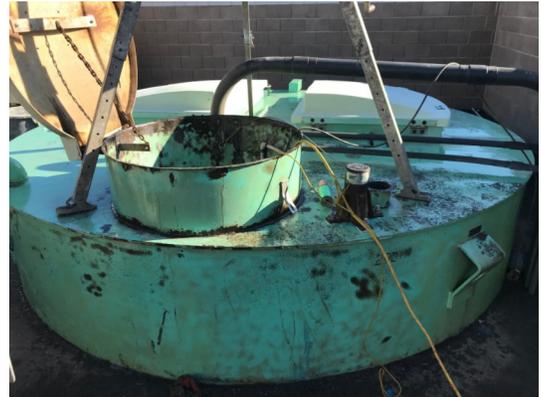
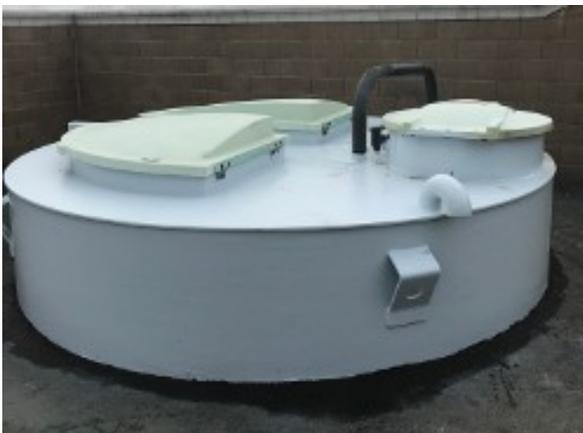
H&R Plumbing was contracted to rehabilitate a badly deteriorated lift station in Oakley, California. High levels of hydrogen sulfide produced a terrible smell and caused extreme corrosion, in many places exposing rebar on the walls. The ceiling and chimney of the lift station were made of steel and included a 4' steel structure meant to protect the pumps and secure the opening of the lift station. Rusted steel in many spots made it clear that these areas were also in need of restoration.
