Case Study: Application of Mainstay Composite Liner Reinforced with Steel Wire Mesh

Contractor: H&R Underground

Location: Davis, CA

Structure: 4' diameter 14' steel lift station

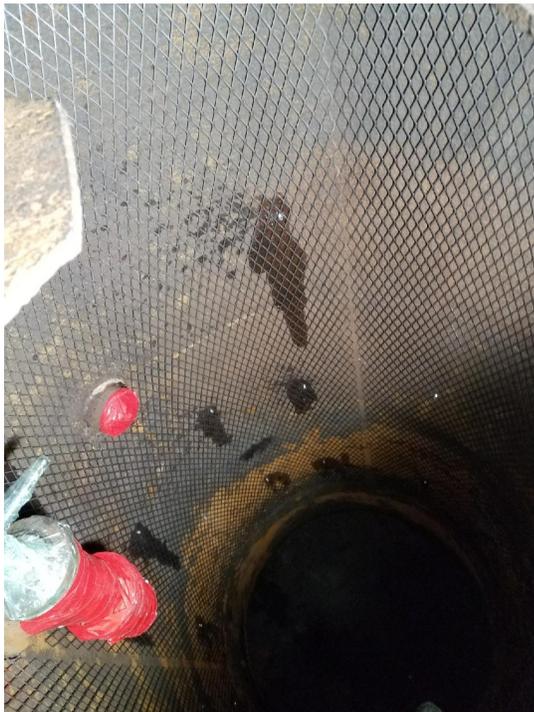
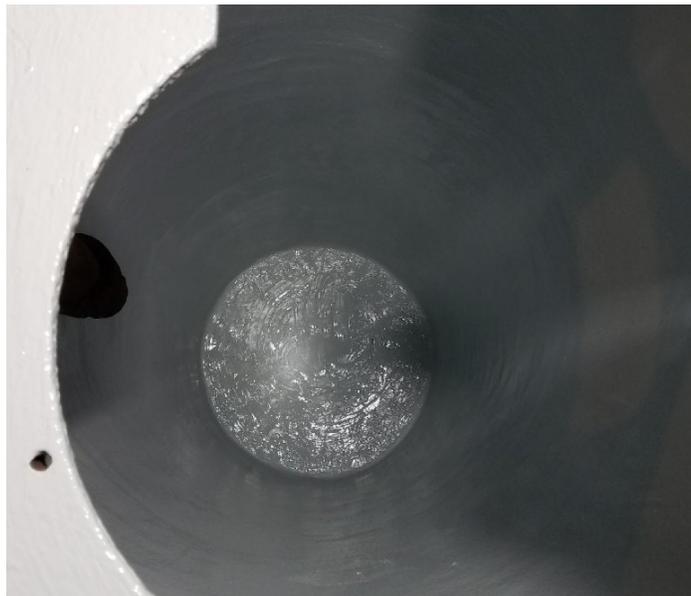
H&R Underground performed an application of the Mainstay Composite Liner reinforced with steel wire mesh on a deteriorated steel lift station in the basement of a facility at UC Davis in California. Sections of the lift station were so badly corroded that the steel surface had been completely eaten away, exposing the surrounding soil. This presented a challenge in regards to creating a strong bond between the Mainstay ML-72 Sprayable Microsilica Mortar and the steel substrate.

To begin, H&R Underground performed surface preparation by dustless abrasive blasting to remove any contaminants and produce a surface profile. The areas of missing steel were then filled using a combination of Mainstay ML-72 Mortar and Mainstay ML-10 Hydraulic Cement Mortar. The combination of these materials produces a rapid-setting material with strong physical properties. After filling these gaps, Stanley steel wire mesh was placed around the inside diameter of the lift station, leaving a 1/2" space between the mesh and the steel substrate. Mainstay ML-72 Mortar was shot onto the steel mesh at 1" to encapsulate the mesh and restore structural integrity. Finally, a 100 mil application of Mainstay DS-5 100% Solids Epoxy Coating was sprayed onto the Mainstay ML-72 Mortar to protect the lift station from future deterioration.
