Case Study: Application of The Mainstay Composite Liner on Treatment Plant Walkways

Location: University of California Davis Treatment Plant, Davis, California

Structure: treatment plant walkways

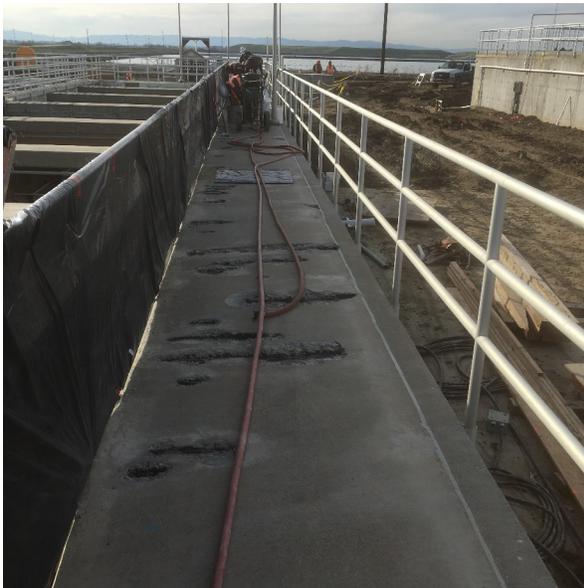
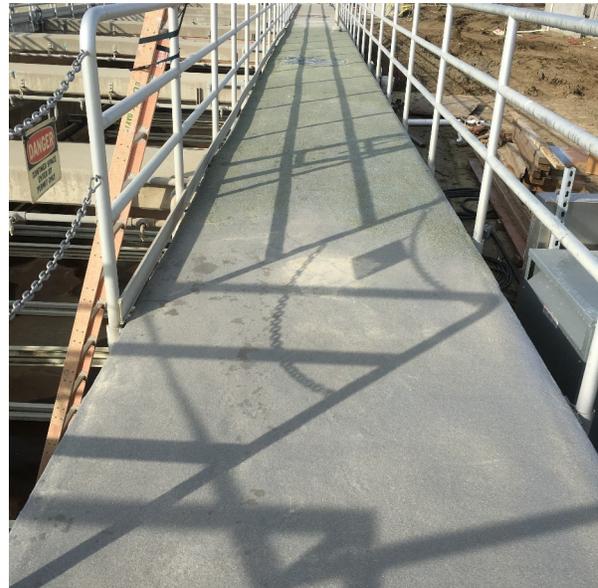
H&R Underground performed an application of the Mainstay Composite Liner on the outside walkways of the University of California's treatment plant in Davis, California. The concrete had deteriorated due to hydrogen sulfide exposure, and the reinforcement bar within the concrete was also exposed.

H&R began by performing surface preparation using a dustless sand blaster to remove any unsound and contaminated concrete. Then, Mainstay ML-72 Sprayable Microsilica Restoration Mortar was applied to build back the concrete surface and cover the exposed rebar. After mortar application, Mainstay DS-5 100% Solids Epoxy Coating was sprayed to provide corrosion protection of the concrete surface from future hydrogen sulfide attack. A gray version of Mainstay DS-5 Epoxy was used instead of white to reduce brightness and glare from sunlight. H&R Underground also provided slip resistance in the floors by broadcasting sand into the uncured coating, creating a slightly rough finished surface. This application was performed in February 2016.
