Case Study: Unique Application of Madewell Products on Aeration Tank Floors

Contractor: Intech Coating Consultants

Location: Atlanta, GA

Structures: Two 40' diameter stainless steel aeration tanks

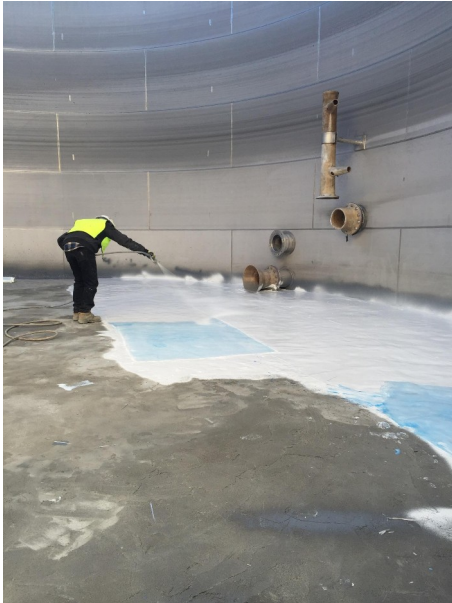
Intech Coating Consultants performed an application of Madewell products on the floors of two steel aeration tanks containing wastewater in a beverage bottling facility. There were a couple challenges to overcome while performing the work. One area of concern was the void space underneath the tanks that would allow the floors to flex when the tanks were full and compromise the integrity of the newly installed laminate system. To address this issue, the void spaces were filled with Mainstay ML-72P Polymer Modified Microsilica Restoration Mortar prior to installing the system.

After filling the void spaces, Intech performed surface preparation by sandblasting to the desired NACE/SSPC Metal Blast Cleaning Standard. The tank floors were coated with 10 mils of Mainstay DS-5 100% Solids Epoxy Coating followed by an application Mainstay ML-72F Microsilica Restoration Mortar. Problems associated with drainage were

prevented by sloping the floors from from 8" on one end to 2" on the other. After mortar application, another 30 mils of Mainstay DS-5 Epoxy was applied. Woven roving was then laid into the wet Mainstay DS-5 Epoxy and saturated with Madewell 1312E Epoxy Saturant to reinforce the system. A final coat of 80 mils of Mainstay DS-5 Epoxy was then sprayed over the laminate to waterproof and protect the underlying system.

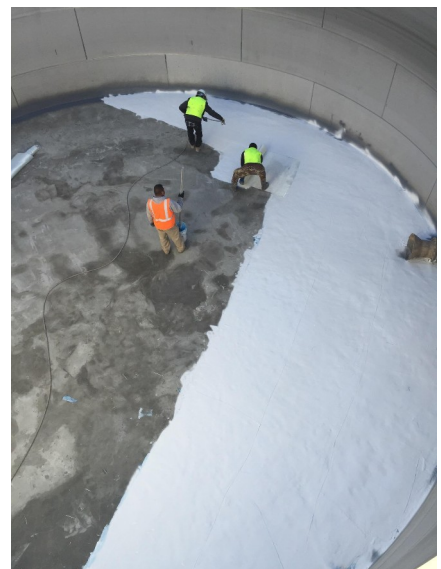
Since only the floors of the tanks required laminate reinforcement, there was a question of where to terminate the system on the walls of the tanks without increasing the risk of coating system failure. The system needed to be terminated in such a way that wastewater could not find its way into the various layers of the system. The terminations also needed to allow the walls to expand and contract somewhat when the tanks were filled and emptied. To solve this problem, Madewell 806 Trowelable Flexible Joint Sealant was applied 3" above and below the termination point of the system on the walls of the tank to accommodate this movement and seal the system.
