Case Study: Cement Mortar Lining Horizontal Concrete Pipe by Centrifugal Application

Contractor: Prism Contractors & Engineers

Location: Williamsburg, VA

Structure: 36-54" concrete storm drain

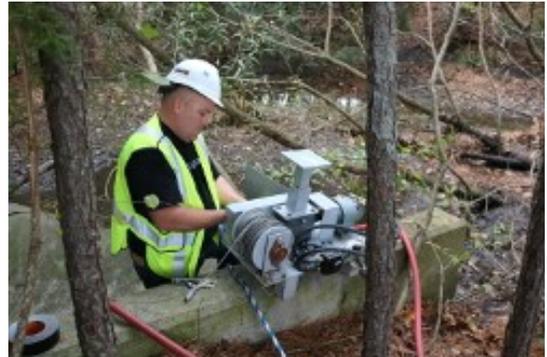
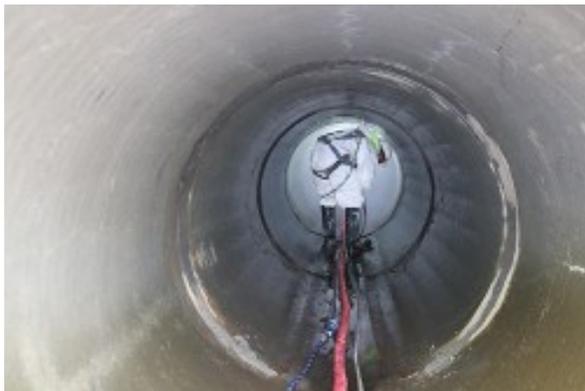
After completing surface preparation, Prism utilized Madewell's horizontal mortar spinner to centrifugally apply 1/2" of Mainstay ML-72 mortar to the inside diameter of the pipe. This mortar spinner is capable of pulling heavy loads horizontally at a very controlled and slow rate of speed. The use of a cable for this application means that the pulling device is able to retract long lengths of mortar hose along with the centrifugal mortar applicator.

One challenge faced by the crew was how to determine the retraction speed needed to apply 1/2" of mortar to various pipe diameters. If the retraction speed is not carefully matched to the pumping rate, the finished mortar lining will not be of the intended thickness. Calculations for each pipe diameter were performed to determine the retraction speed required at a typical pumping rate of 100 pounds per minute. As the mortar was being spun onto the pipe, a crew member followed behind to spray water onto the uncured mortar to
