Case Study: Application of Mainstay ML-72 Mortar to 10,000 SF of Equalization Basin

Contractor: Culy Contracting, Inc.
Location: Longmont, Colorado
Structure: concrete equalization basin
Date: June 2018

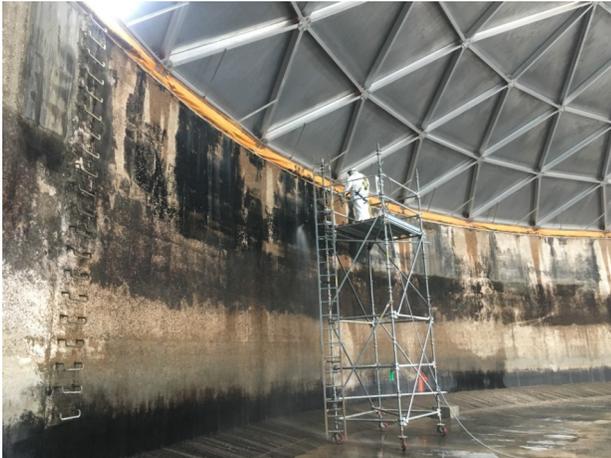
Culy Contracting, Inc. completed a project for the City of Longmont in Colorado that utilized over 2,500 bags of Mainstay ML-72 Sprayable Microsilica Restoration Mortar. A crucial concrete equalization basin at the City's wastewater treatment plant had experienced severe corrosion due to high levels of hydrogen sulfide gases. To repair the structure, Culy was contracted to apply 1.5" of Mainstay ML-72 to approximately 10,000 SF of the basin's concrete walls.

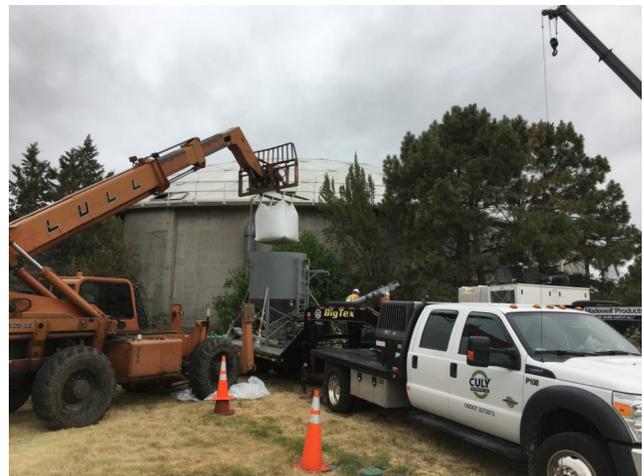
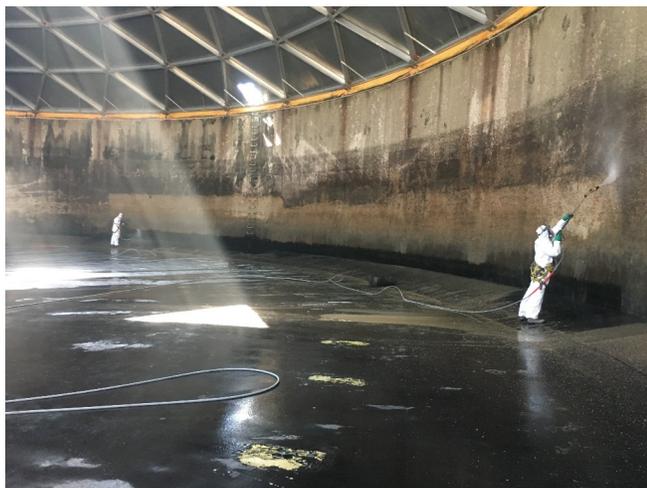
To accommodate the short timeline, Culy coordinated the work in continuous 12-hour shifts. It quickly became obvious that it would not be possible for the mortar mixer operator to lift, break, and mix 65-pound bags of mortar for twelve hours at a time, so Culy utilized the Madewell Mortar Silo to store and dispense super sacks of mortar into the mixer. With this piece of equipment in place, the flip of a hydraulic valve commands an auger to move the mortar from the silo to the mixer. 52 skids of Mainstay ML-72 were delivered to the jobsite in one day to provide a continuous supply of mortar for the project.

Surface preparation was performed by a local contractor prior to mortar application. The deteriorated concrete substrate was removed by water blasting at 5,000 psi. Steps inside of the tank were removed, and the lining process was allowed to begin.

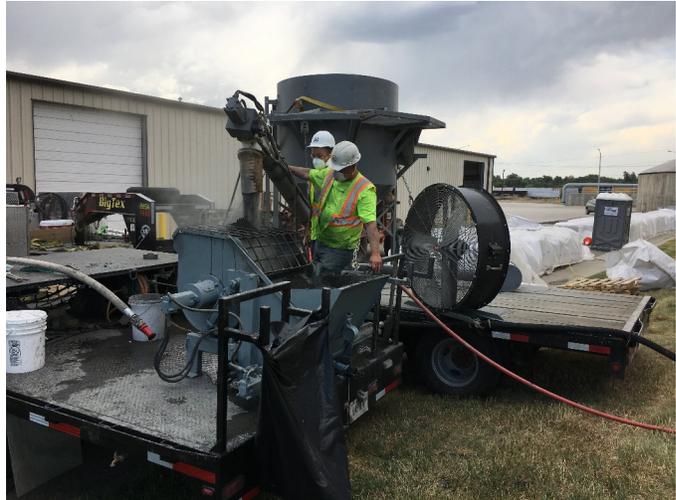
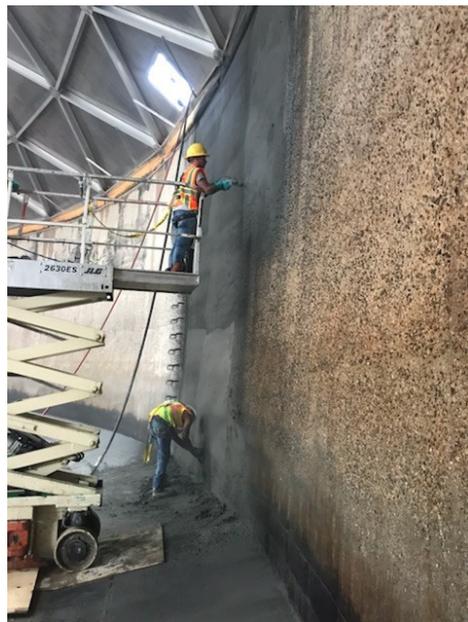
Using a telescopic loader, super sacks of mortar were loaded into the silo, which was mounted on a separate trailer from the mortar mixer. This allowed the auger to move over the mixer and back out of the way and provided easier access for the mixer operator. Mortar was pumped 125 feet through 1.25" hose for 96 hours nonstop using the robust Madewell Mortar Mixer. The rotor and stator were replaced twice during mortar application due to wear and tear.

Mainstay ML-72 mortar was applied in 6-foot-wide sections at 1.5" thick using Madewell shotcrete equipment and scissor lifts. Each section was dampened with water prior to mortar application. The mortar was hand troweled smooth and broom finished to achieve a slightly textured surface. After finishing, a water-based concrete sealer was applied to prevent cracking.
