# Case Study: Restoring a Manhole Within a Manhole using Mainstay ML-72 Mortar

**Contractor:** The Expeditors  
**Location:** Milwaukee, WI  
**Structures:** Double barrel manholes  
**Year:** 2017

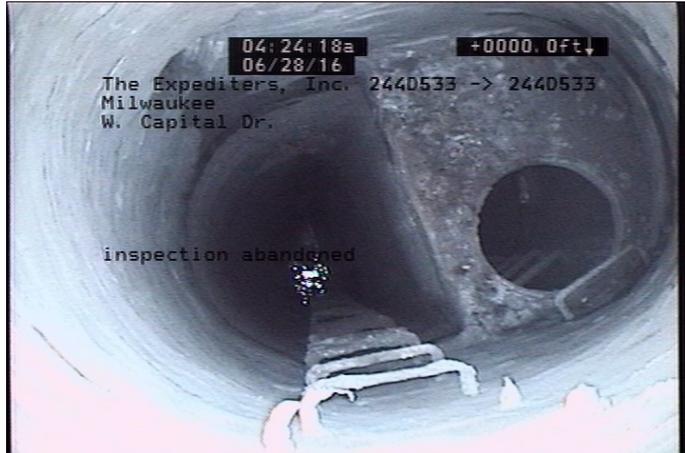
The Expeditors performed an application of the Mainstay Composite Liner on what was essentially a manhole within a manhole. The project required the rehabilitation of very deep manholes, with some up to 48' deep. This particular "double barrel" manhole had a 72" combination sewer pipe running through it on one side and an 18" sanitary sewer pipe running through it on the other side at the same depth.

Because the manhole was so badly deteriorated that it was no longer structurally sound, the first challenge to overcome was figuring out how to restore the manhole with minimal human entry. The Expeditors used a Vactor truck with an ENZe pressure washing head, typically used for cleaning lift stations, to perform surface preparation. After pressure washing, a crew member stopped any active leaks inside the manhole using Mainstay ML-10 Hydraulic Cement Mortar.
